Inverter-Based Resource Disturbance Analysis

Key Findings and Recommendations

Informational Webinar
February 15, 2018

August 16, 2016
Blue Cut Fire Disturbance

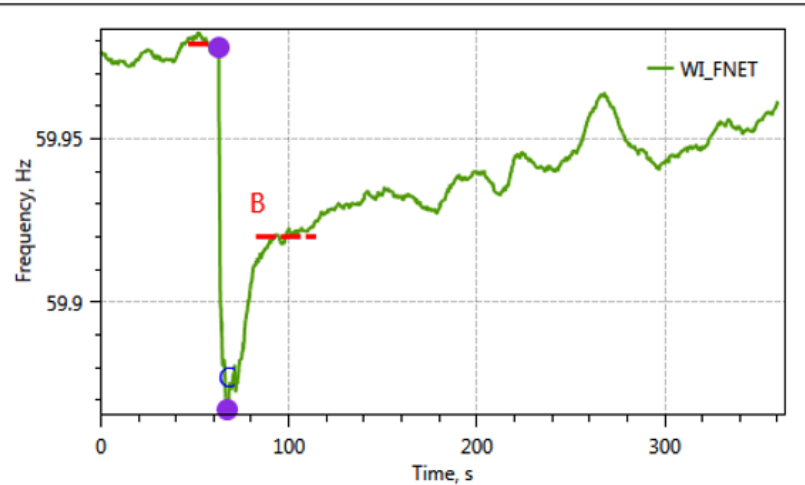
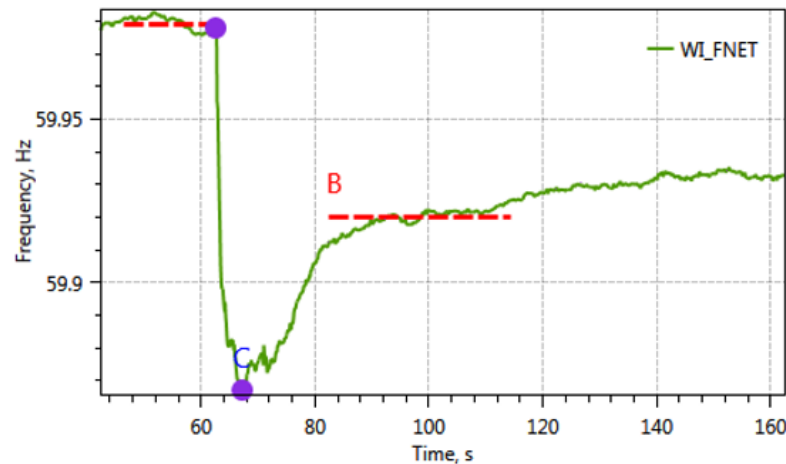
WI_20160816_184506

- Largest block of solar PV loss (~700 MW) due to underfrequency tripping
- Inverter sensed a near instantaneous frequency of <57 Hz and tripped instantaneously

- Isolated to one inverter manufacturer
- Manufacturer quickly devised solution following event
- Added time delay to inverter frequency tripping
 - Allows inverter to “ride through” transient/distorted waveform period without tripping.

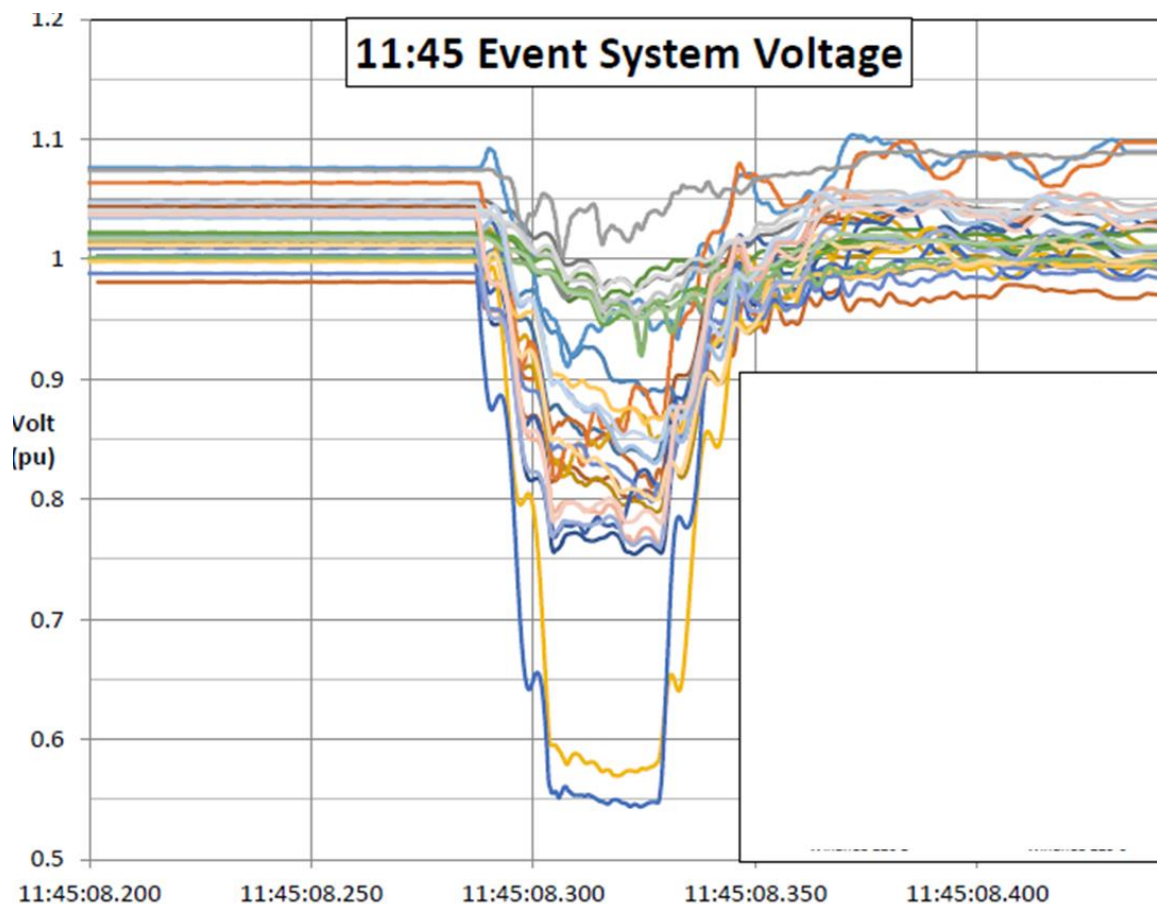
- 2nd largest block of inverter loss (~450 MW) was attributed to low voltage

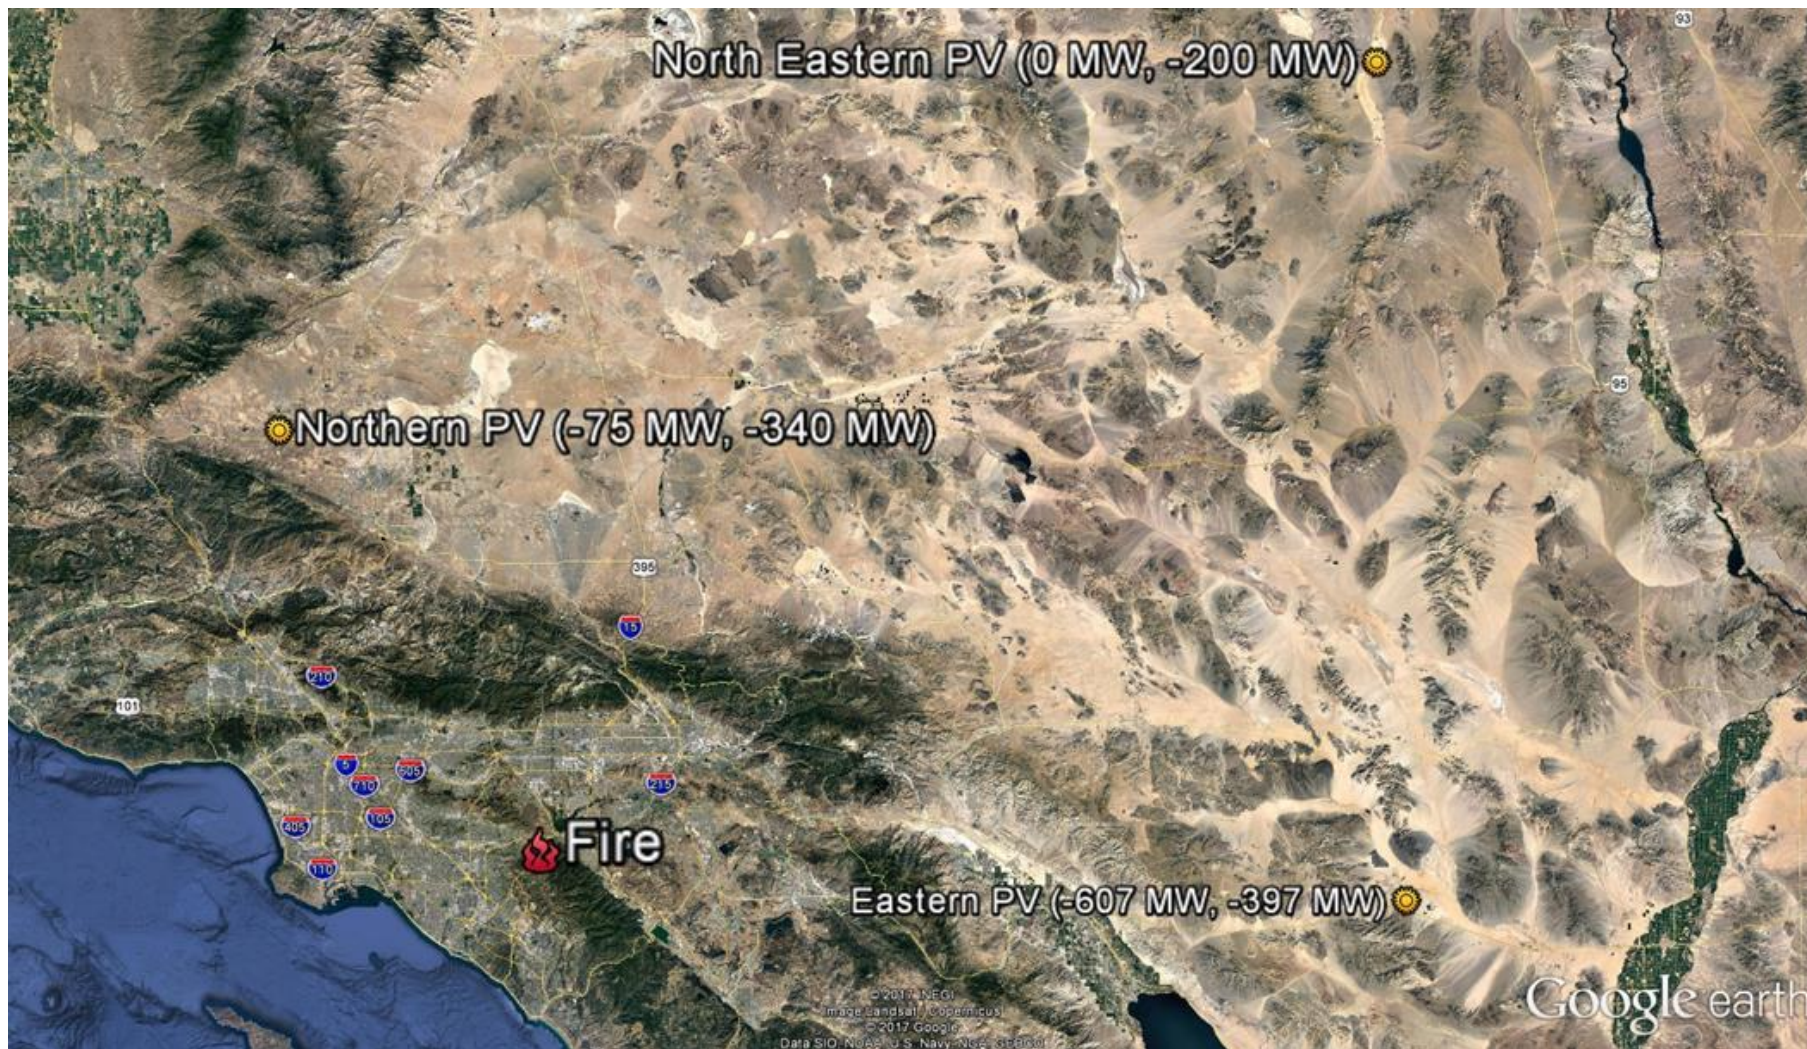
*Smoke-induced L-L fault events caused by Canyon 2 Fire...
Both fault cleared normally...*

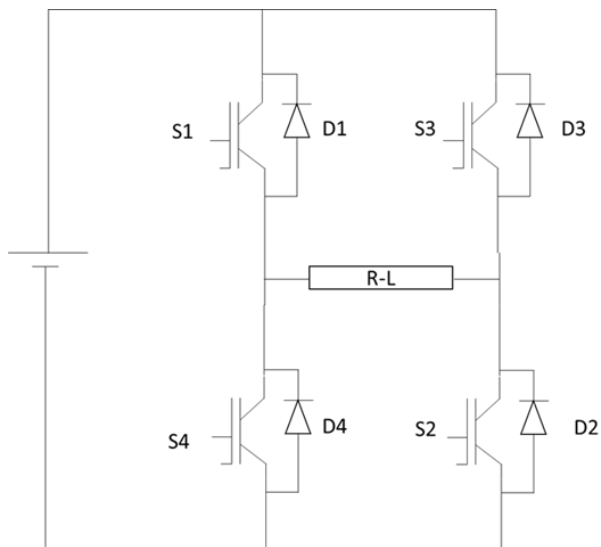
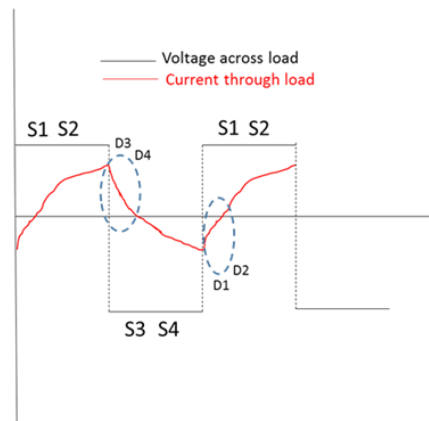
DC reverse current tripping

- Anti-parallel diodes dissipate energy, mitigate voltage spikes
- Can conduct if forward biased (AC voltage > DC voltage)
- UL 1741 requires testing and detection, no specified trip settings
- DC reverse current detection protects panels, not inverter
- Very sensitive settings for one plant
