Inverter-Based Resource Disturbance Analysis

Key Findings and Recommendations

Informational Webinar
February 15, 2018

August 16, 2016
Blue Cut Fire Disturbance

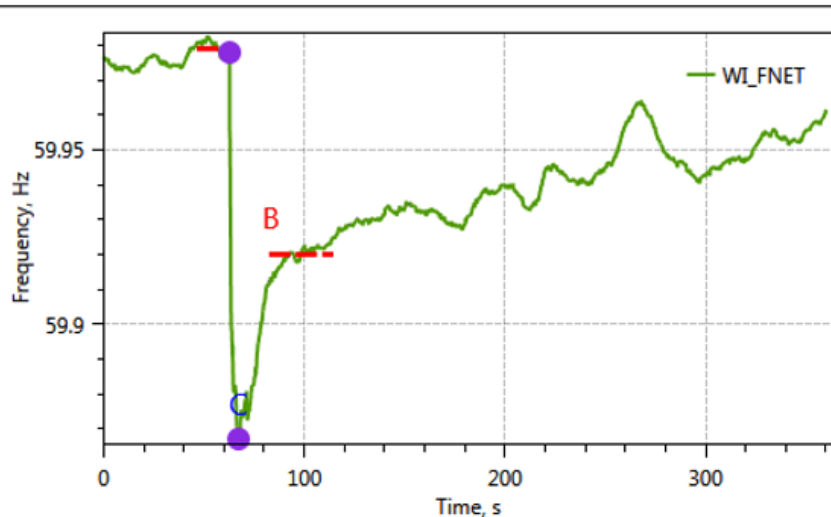
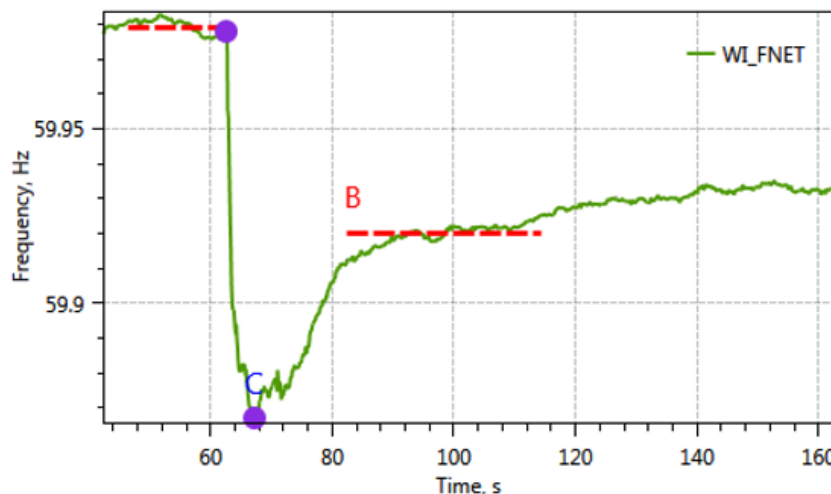
WI_20160816_184506

- Largest block of solar PV loss (~700 MW) due to underfrequency tripping
- Inverter sensed a near instantaneous frequency of <57 Hz and tripped instantaneously

- Isolated to one inverter manufacturer
- Manufacturer quickly devised solution following event
- Added time delay to inverter frequency tripping
 - Allows inverter to “ride through” transient/distorted waveform period without tripping.

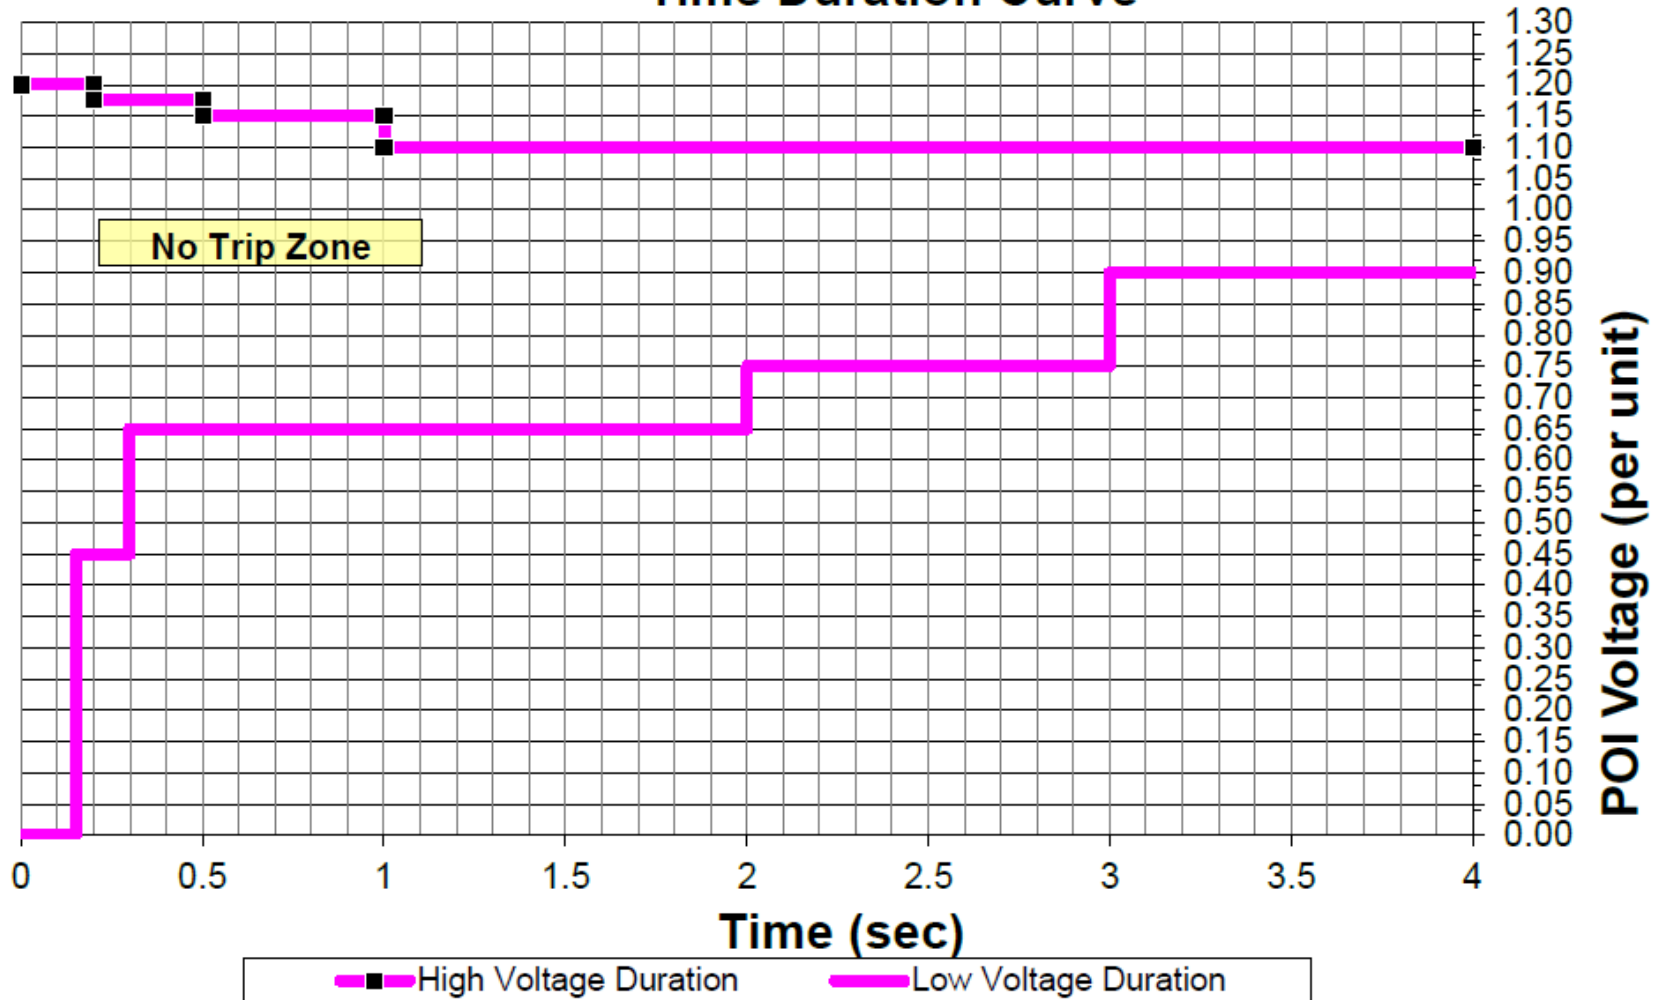
Voltage Ride-Through Time Duration Curve

- Inverters have three modes of operation
 - Operating (injecting active current into the system)
 - Momentary Cessation (momentarily cease to inject current during voltages outside continuous operating range - .9 to 1.0 per unit)
 - Trip (cease to inject current, disconnect from grid, wait ~ five minutes and return to service if grid voltage and frequency are within bounds)

- The inverters did not “Trip”, they went into Momentary Cessation
- Majority of installed inverters set to momentarily cease current injection for voltages of $V < .9$ p.u. or $V > 1.1$ p.u.
- In inverter language, Momentary Cessation does not equal trip

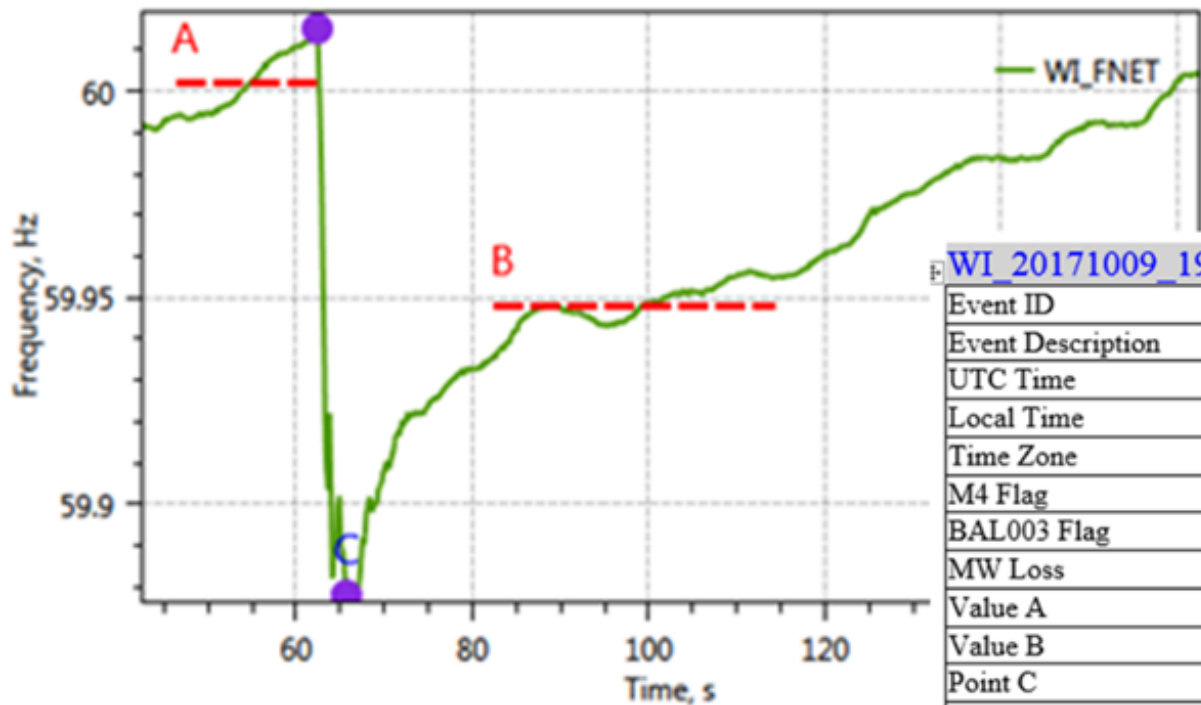
Event ID	WI_20171009_191428
Event Description	"Solar Generation 900MW loss"
UTC Time	10/09/2017 19:14:28
Local Time	10/09/2017 12:14:28
Time Zone	PDT
M4 Flag	Yes
BAL003 Flag	Yes
MW Loss	900
Value A	60.002
Value B	59.948
Point C	59.878
Time of C	3.3
Point C'	-
Time of C'	-
A-B [mHz]	54
A-C [mHz]	124
FRM_B [MW/0.1Hz]	1667
FRM_C [MW/0.1Hz]	726

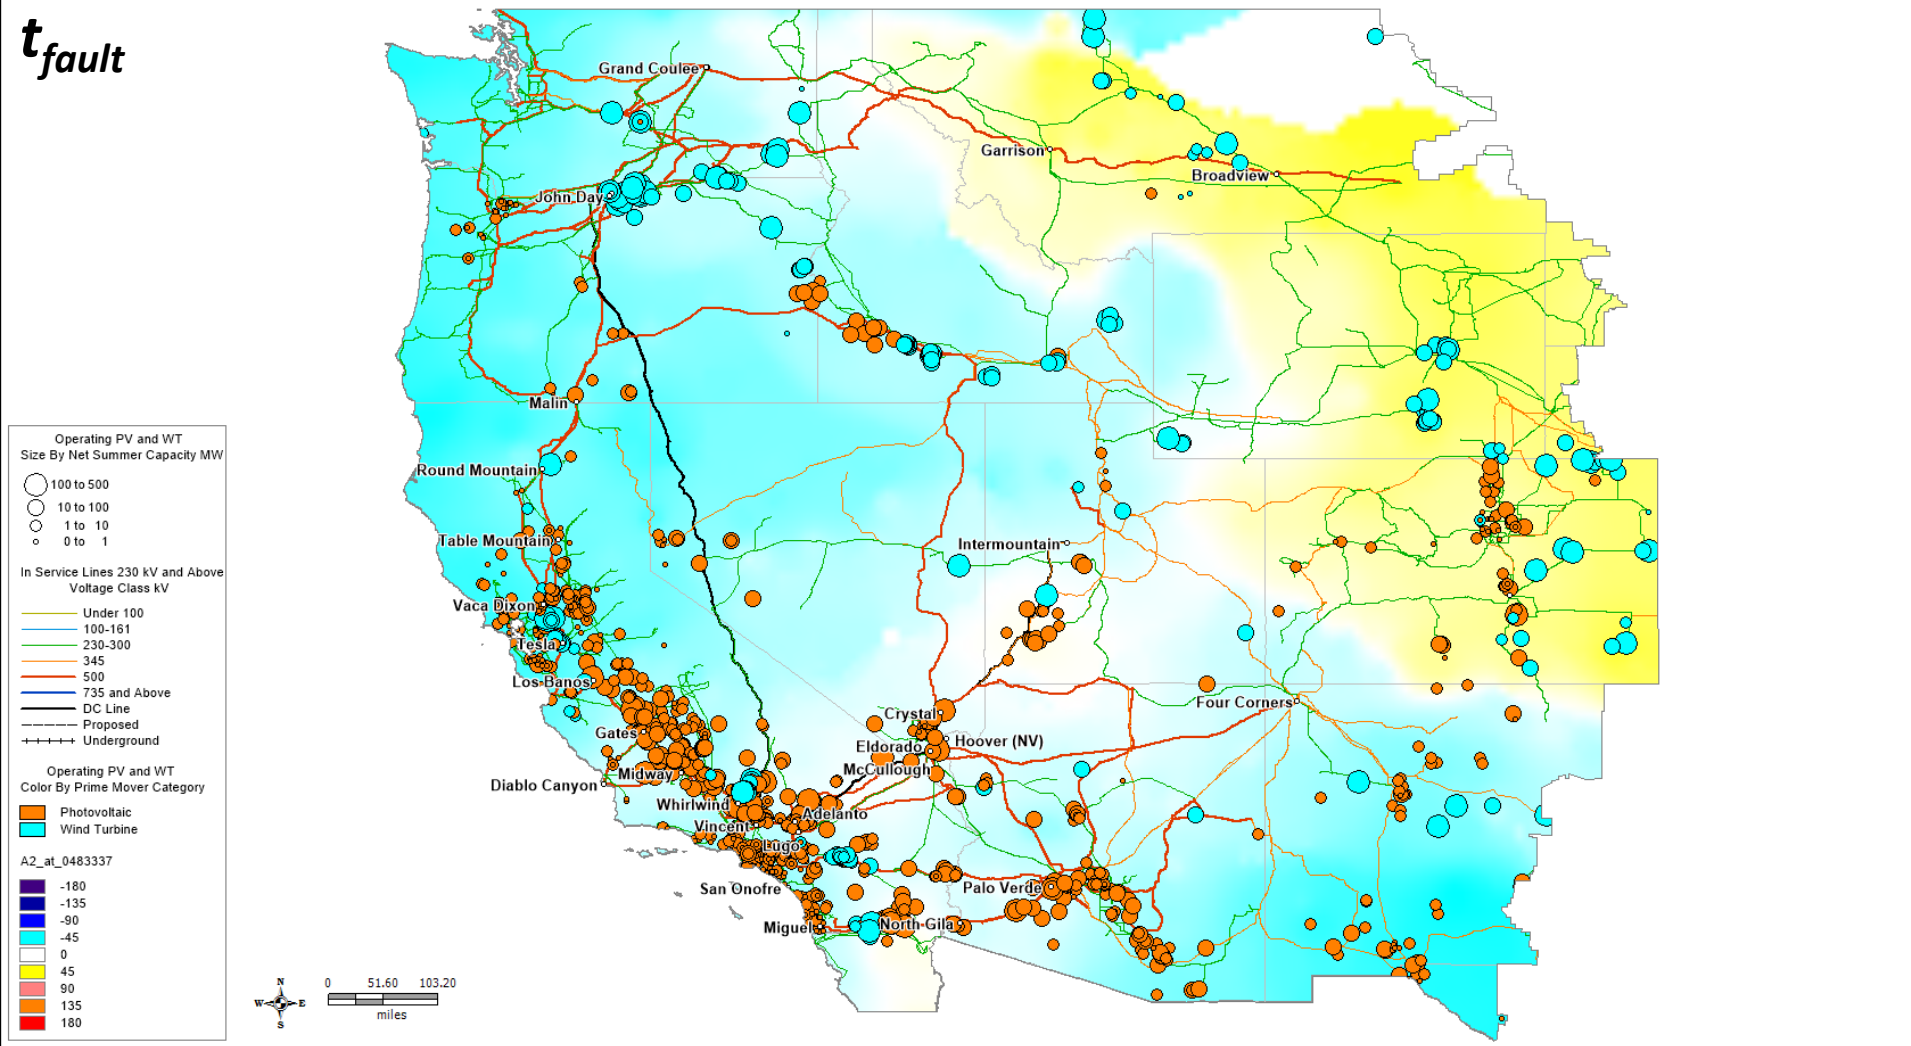
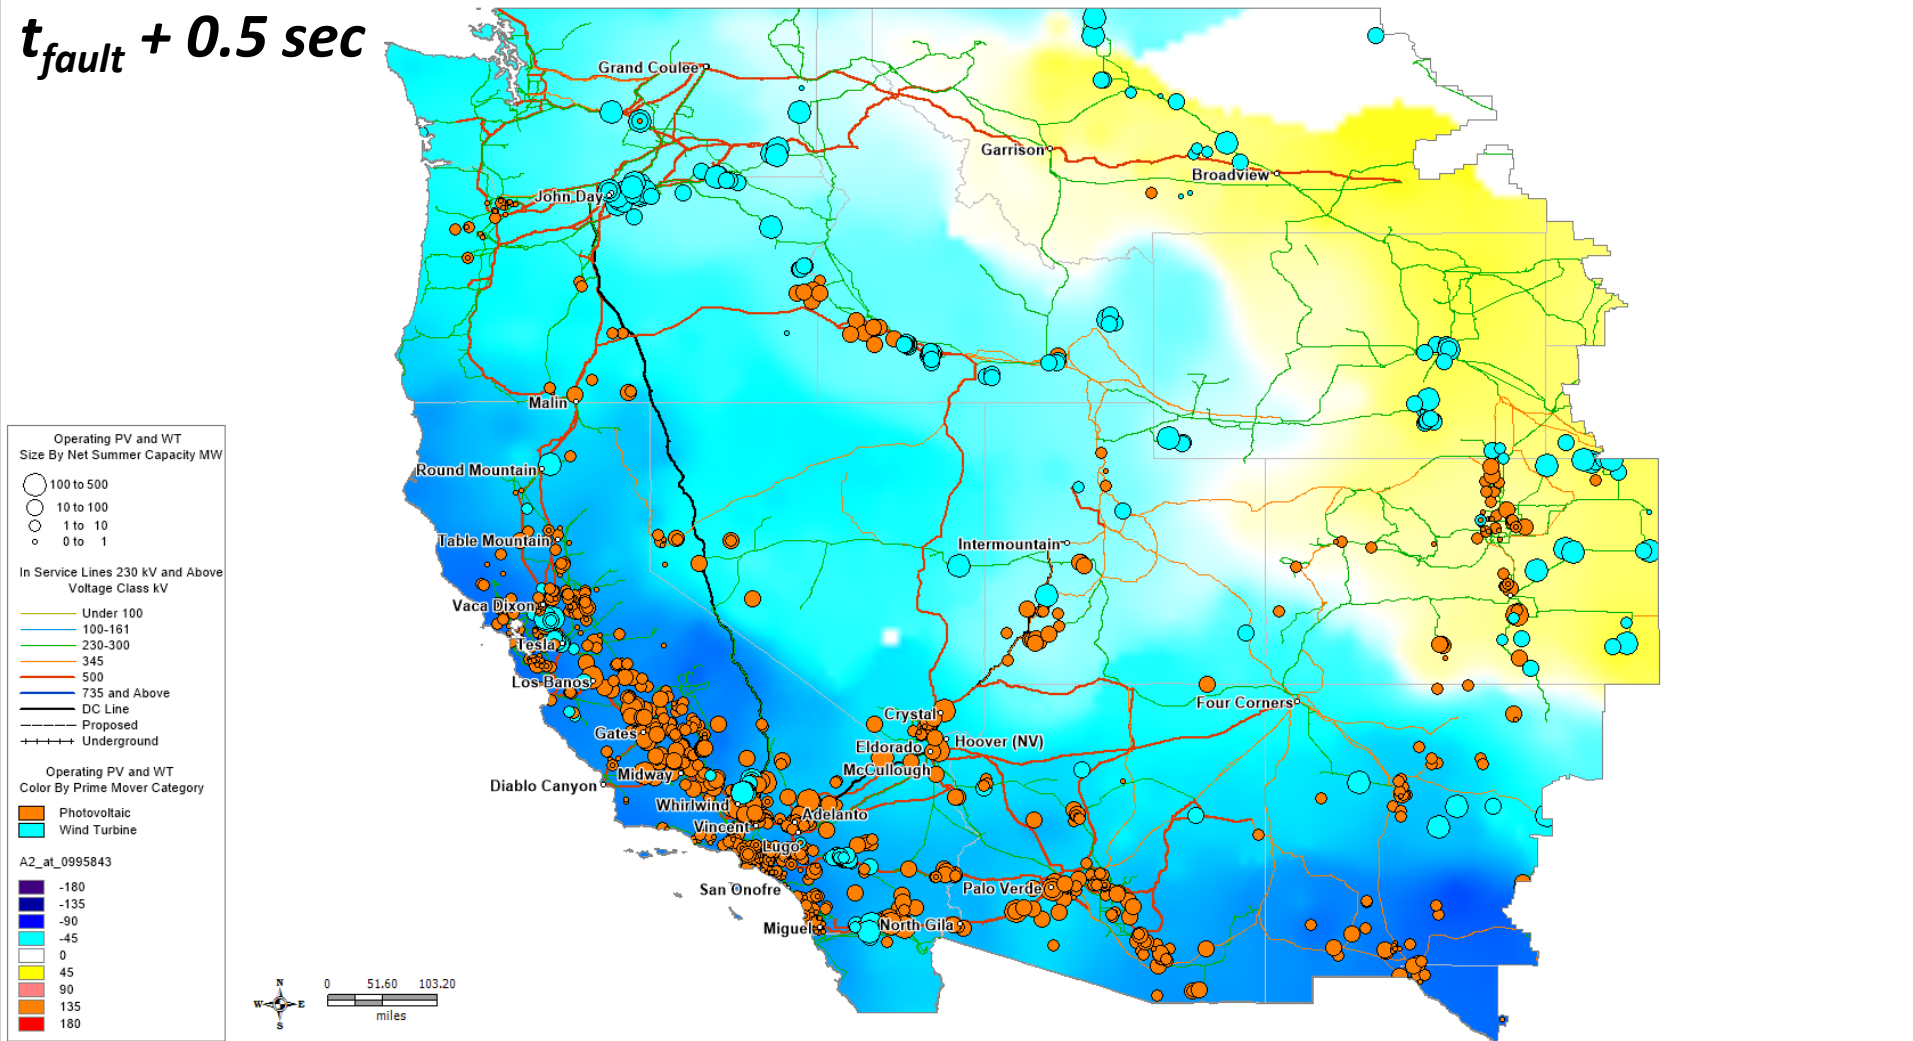
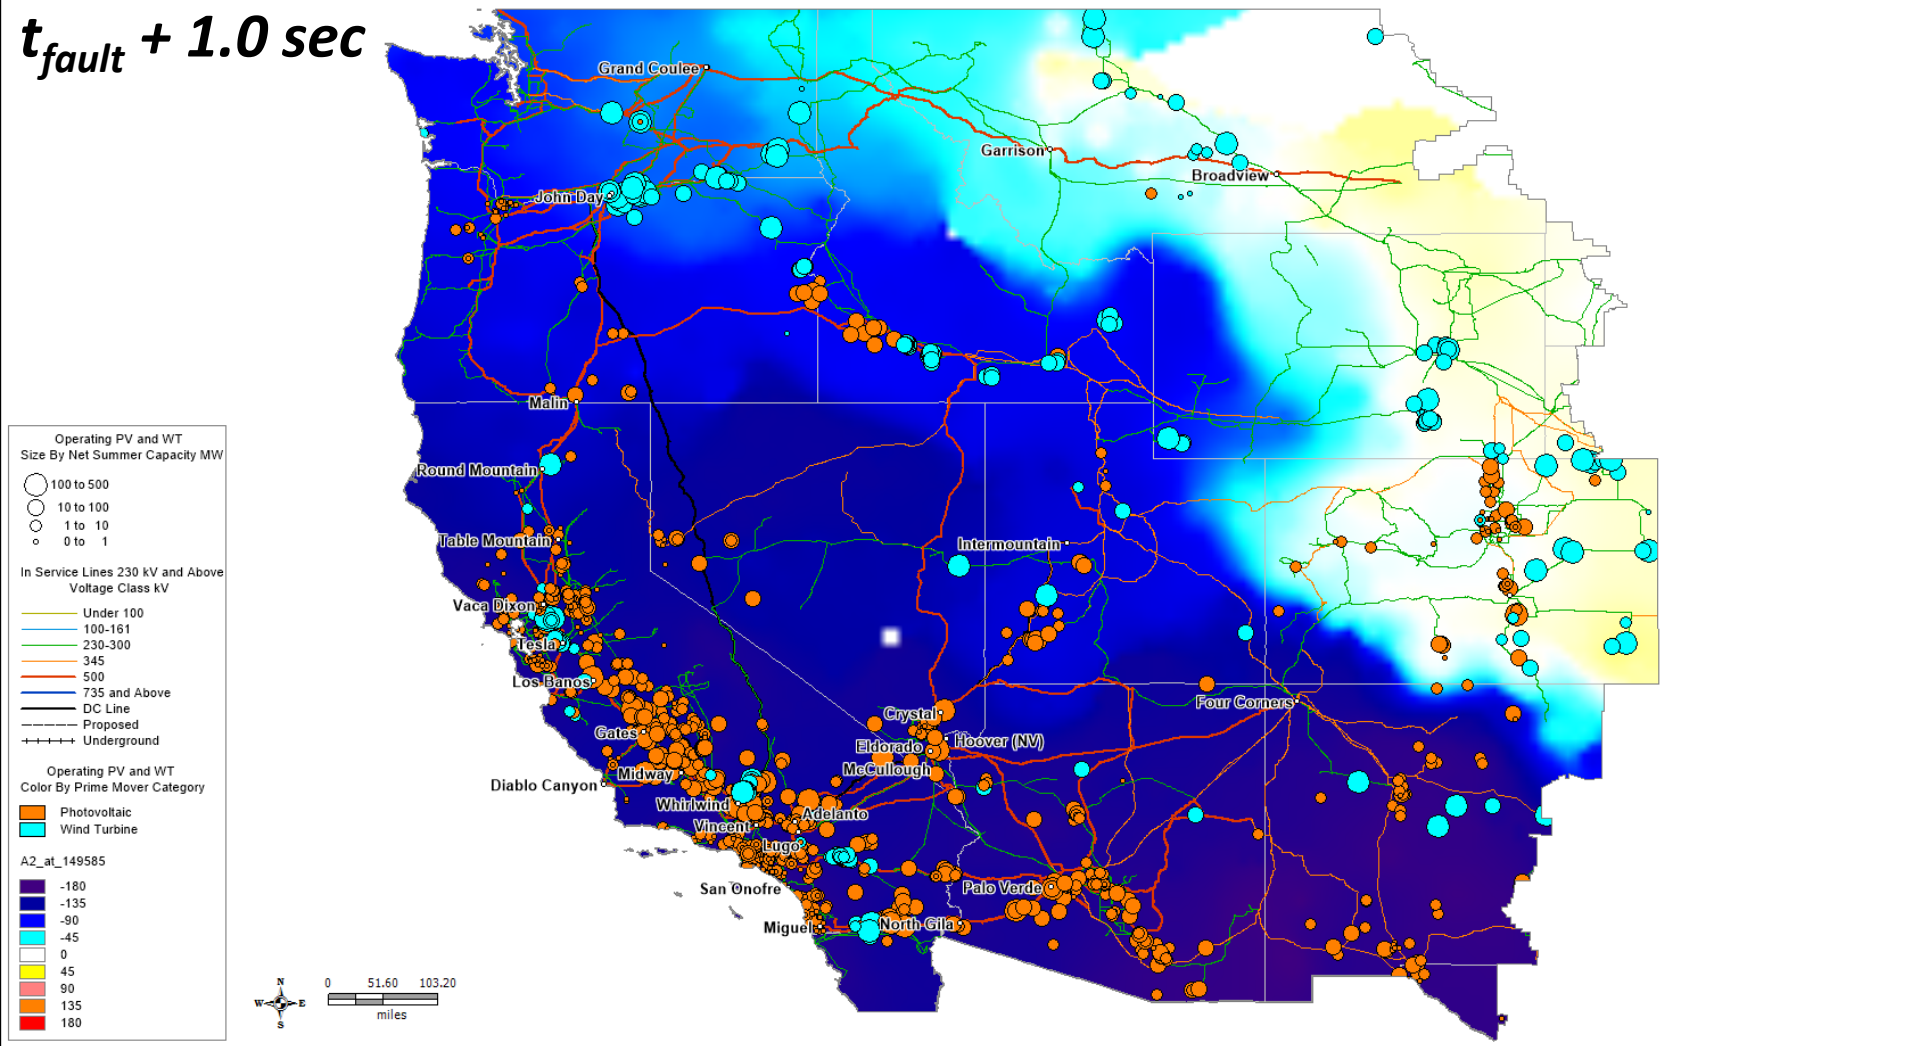
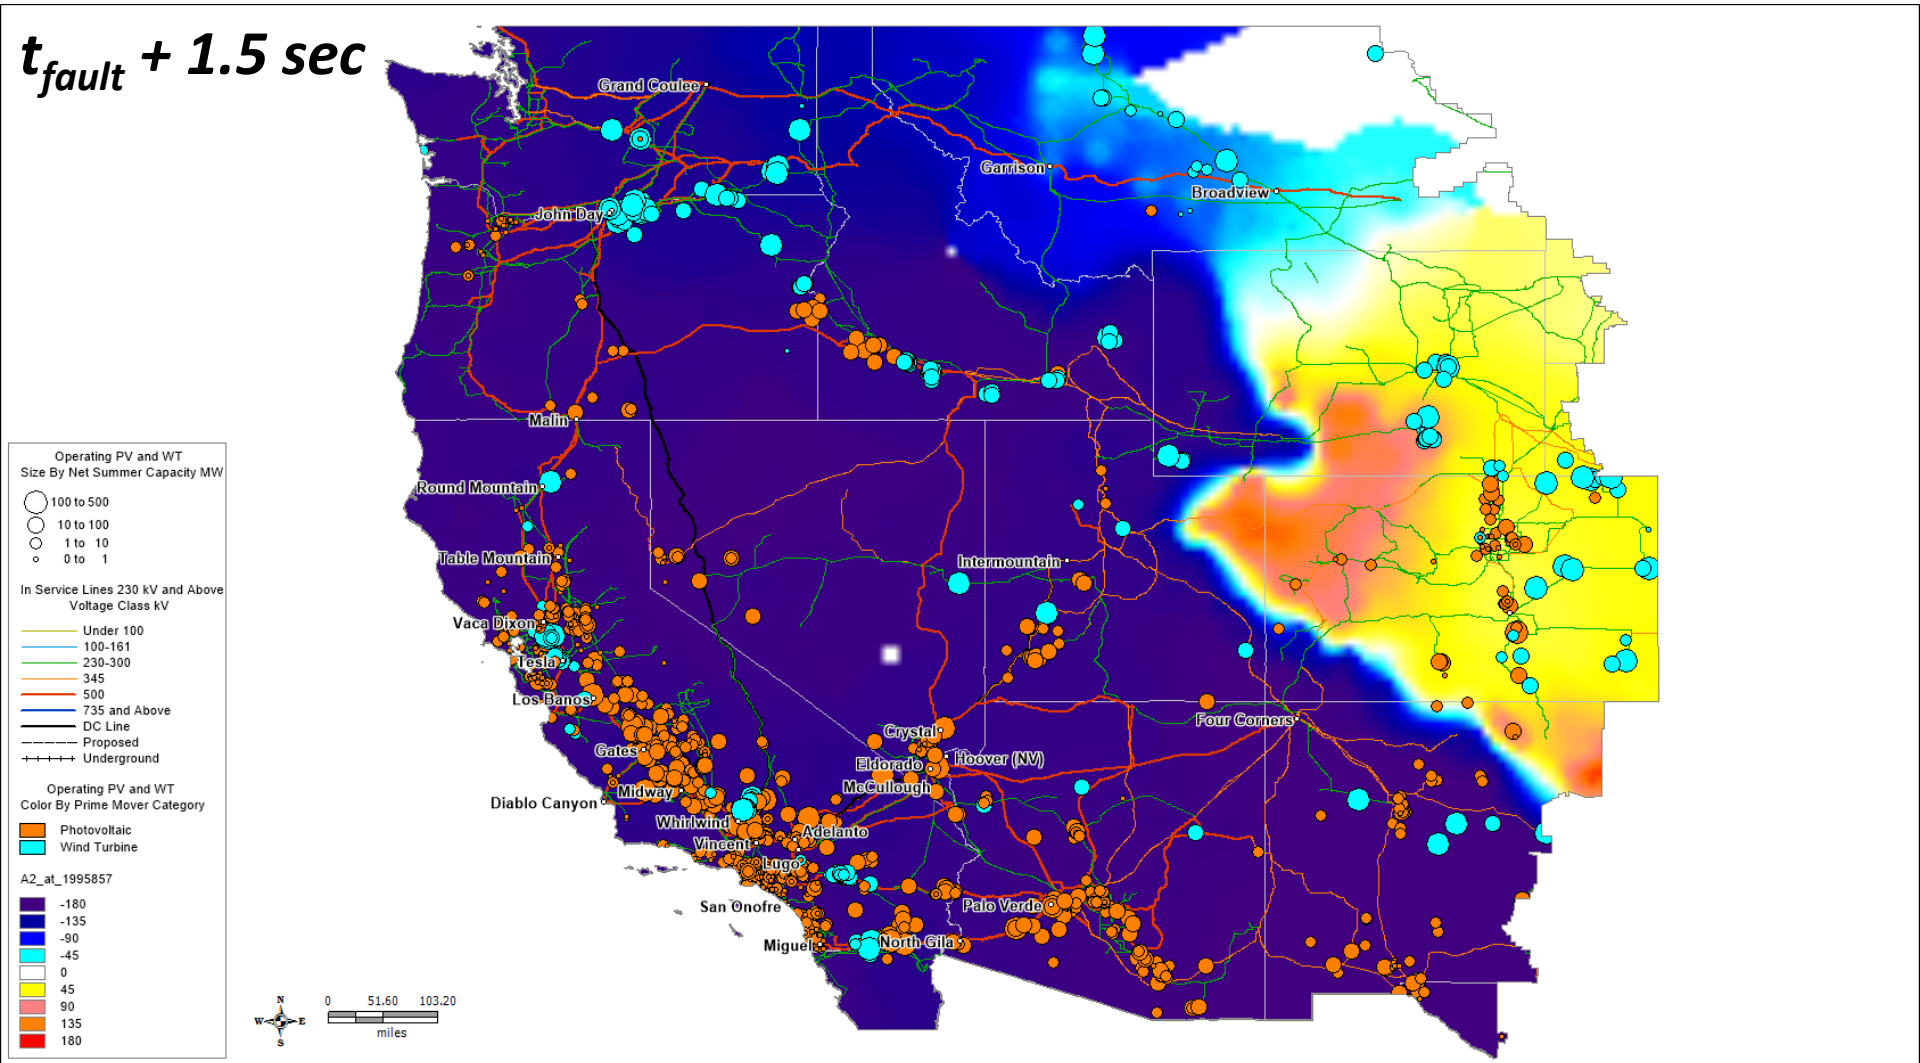
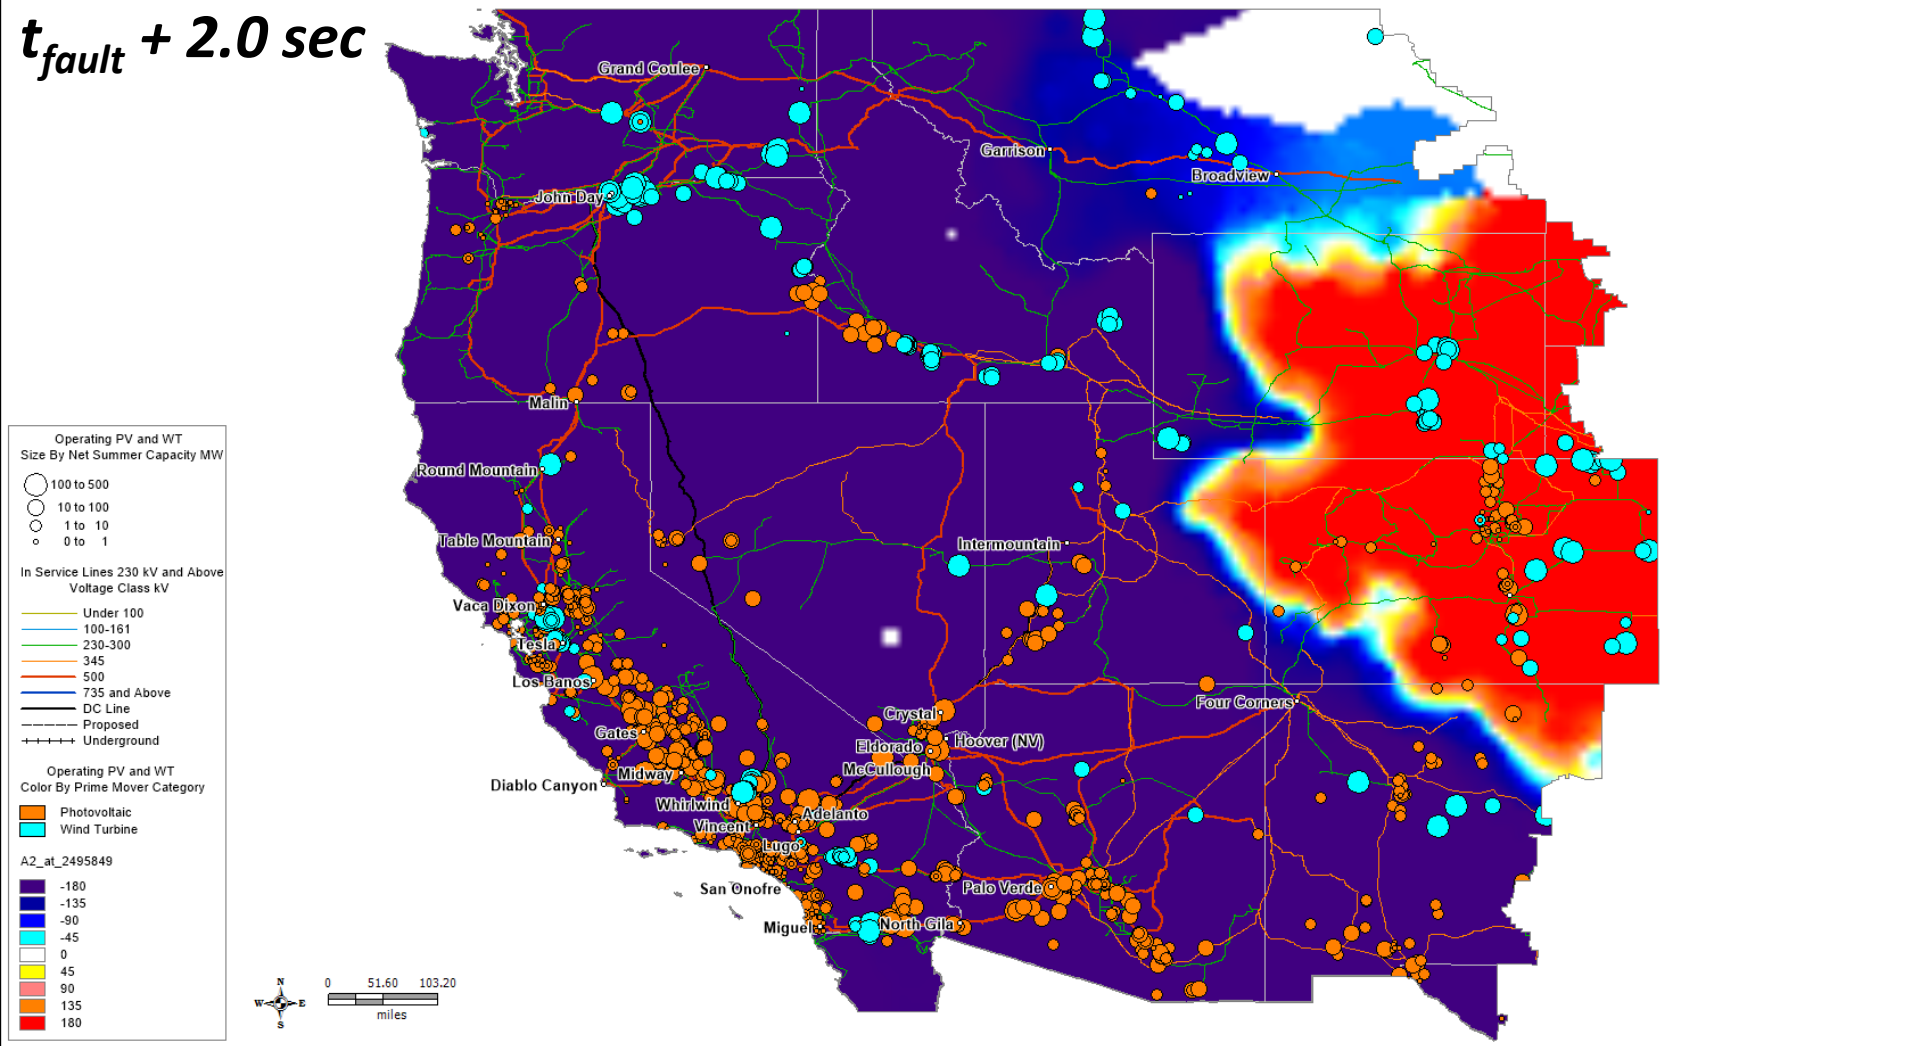
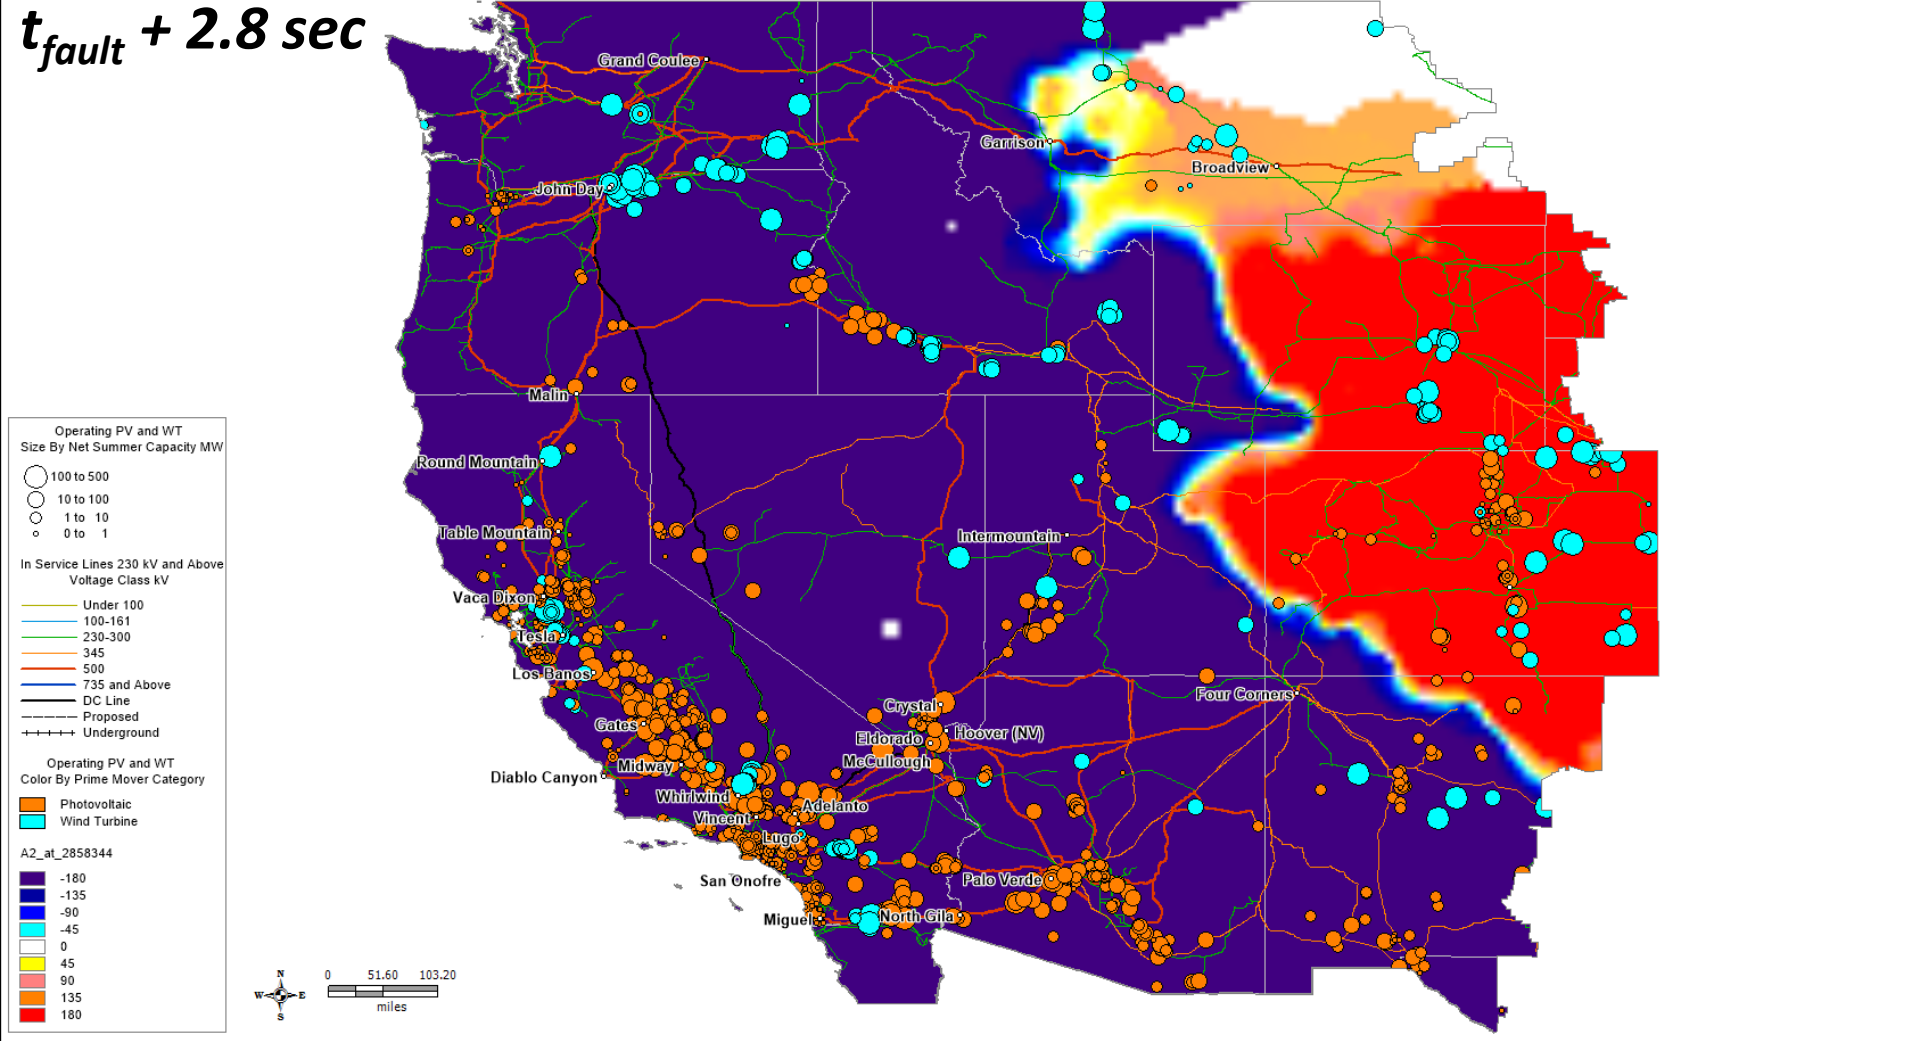
- Majority of existing inverters use momentary cessation
- Most use a low voltage threshold of ~ 0.9 pu
- Recovery of current following momentary cessation varies, relatively slow for grid dynamics
- Blue Cut Fire recommendation – interim solution
- NERC IRPTF studies – new recommendation
 - Stability studies show potential BPS wide-area stability issues

- Generator Owners should coordinate with their inverter manufacturer(s) to **eliminate momentary cessation (MC) to the greatest extent possible.**
- For inverters where MC cannot be eliminated (e.g., use another form of ride-through mode), MC settings should be changed by:
 - Reducing the MC low voltage threshold to the lowest value possible.
 - Reducing the recovery delay to the smallest value possible (e.g., on the order of 1-3 electrical cycles).
 - Increasing the active power ramp rate to at least 100% per second (e.g., return to pre-disturbance active current injection within 1 second).
 - Setting reactive current priority upon recovery (if applicable) should eliminate the use of MC on all inverters that are capable of continuous current injection during abnormal voltages.

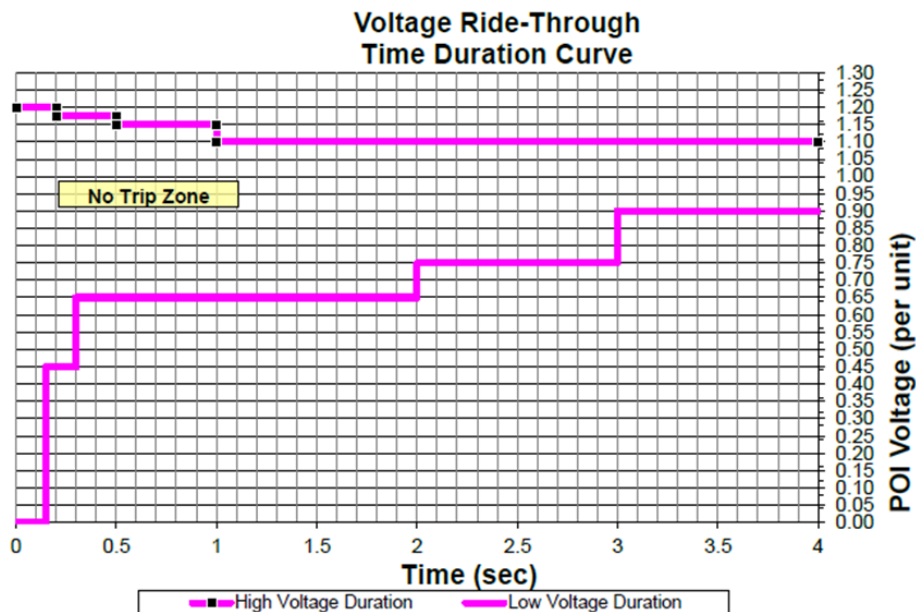
Interpretation of PRC-024-2 voltage ride-through curve

This curve is a minimum requirement.

This curves should NOT be a design criteria.

Protection should be set based on equipment limitations.

Equipment should be designed as robust as possible.

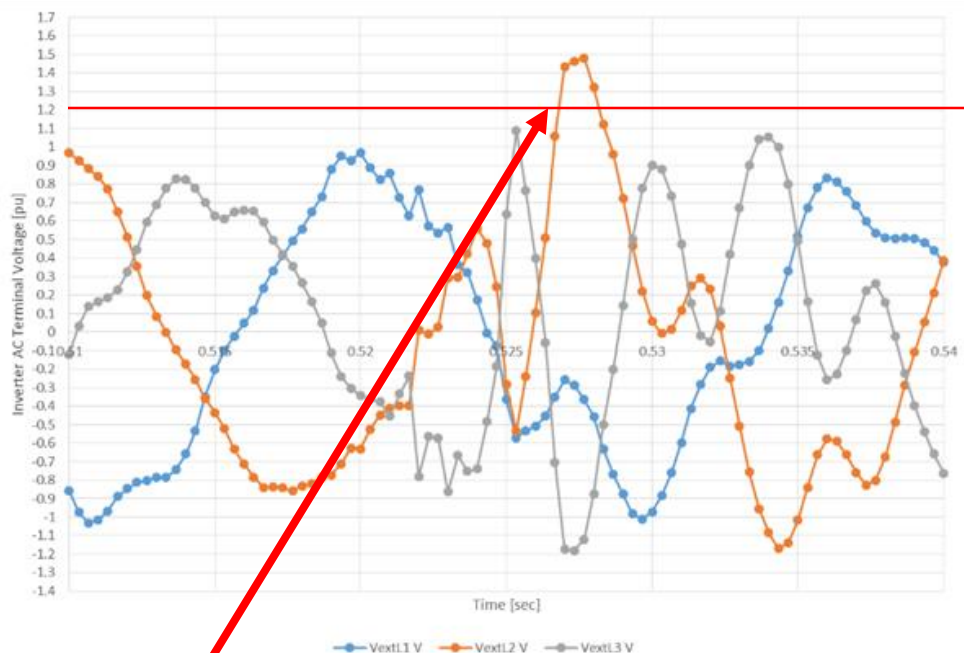
Instantaneous voltage tripping and measurement filtering

Inst. Voltage [pu nominal peak]	Samples	Time [sec]	Cycles
> 1.1	5	0.00167	0.1
> 1.2	4	0.00133	0.08
> 1.3	4	0.00133	0.08
> 1.4	3	0.00100	0.06

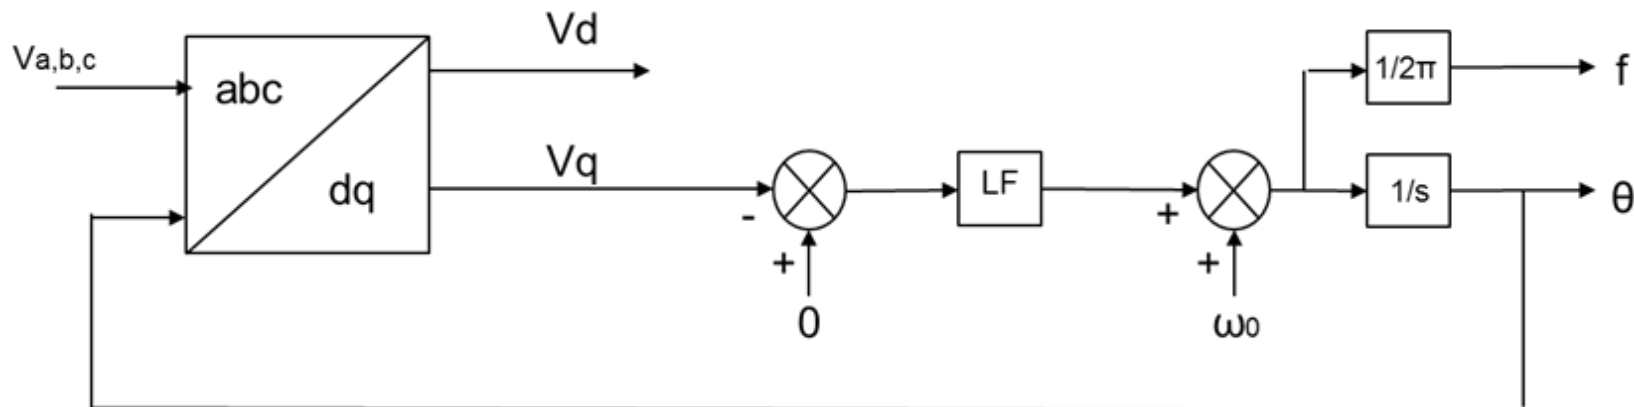
Phase lock loop synchronization issues

- Grid voltage phase jumps occur (e.g., during faults)
- Inverter PLLs should be robust to withstand BPS phase jumps
- Should not result in inverter tripping or momentary cessation
- Advanced controls should enable “PLL ride-through” rather than tripping
